PRODUCTS: SEALROOF A-100

APPLICATION: TILE ROOF RESTORATION

APPLICATOR: LIQUID RUBBER INDUSTRIES SA.

CLIENT: Private residence LOCATION: Mpumalanga, South Africa

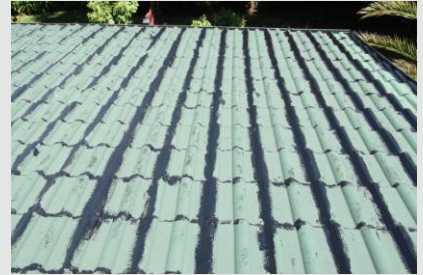
JOINS ARE SEALED WITH HIGHBUILD S-200

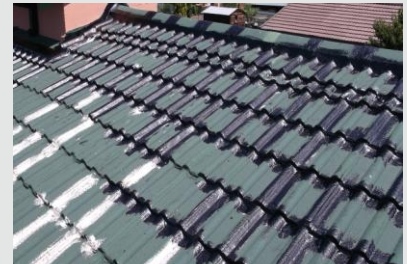
MORTAR IS REPLACE AND SEALED WITH HIGHBUILD S-200

Liquid Rubber Solution: The old mortar was removed and the lap joints re-pointed. Liquid Rubber HighBuild S-200 was applied over the new mortar. Once the entire roof was cleaned to remove moss, lichen and other debris, Liquid Rubber SealRoof A-100 was spray applied in three coats to seal the surface and provide a smooth uniform reflective waterproofing membrane.

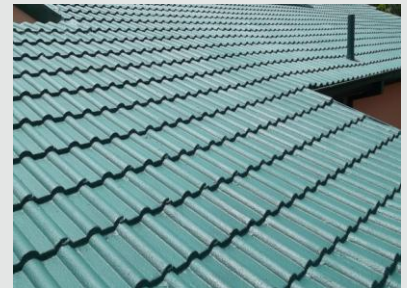
ROOF IS COATED WITH SEALROOF A-100

An attractive finished appearance, Liquid Rubber SealRoof A-100 cures to a strong waterproof membrane with the flexibility to move with the roof under wind loading and not crack.
